**INSTRUCTIONS FOR TRANSPORTATION,
HANDLING, STORAGE OF THE DRUMS AND
LAYING OF THE CABLES**

Document No:

Revision : 00

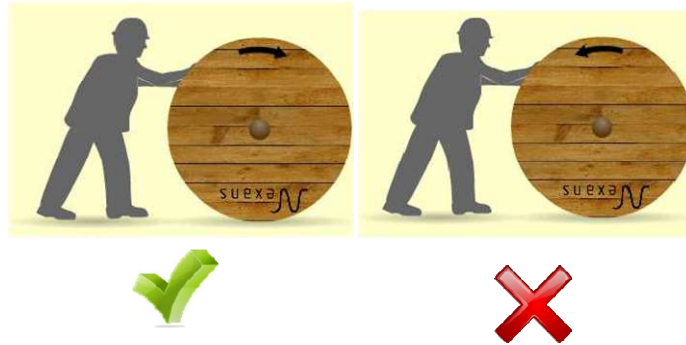
Drum flanges are marked to provide vital information to assist with the handling of the drums and the installation of the cable. This information includes drum weight, a mark on the flange indicating the end of the cable, and an arrow indicating the direction the drum is to be rolled during rolling or transportation.

The rolling of the drum in the direction of the arrow ensures that there is no tendency for the cable to loosen its wind on the drum. It should be noted that when pulling the cable off the drum and installing the cable, the arrow will point in the opposite direction to the rotation of the drum.

It should be noted that when pulling the cable off the drum, the arrow (painted on the flange of the drum) will point in the opposite direction to the rotation of the drum. This is an expected practice.

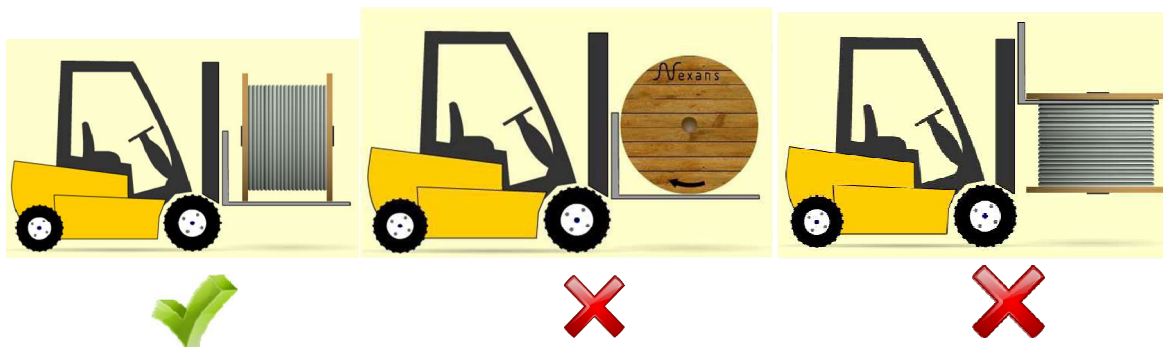
In general, the forklift truck method of drum handling is only applicable where a hard and level ground surface is available. This is required in the intended storage area. In this case a forklift capable of lifting about 12 tonnes will be required (maximum drum weight plus contingency). It is also necessary to ensure that the forklift truck tines are capable of traversing the width of the drum and provide support to both flanges.

For the smaller drums, tines of 1200 mm length will be satisfactory. The larger drums will require tines of 1800 mm length. For the larger drums, for example containing 33 kV or 132 kV cables or long lengths of cable, it will be necessary to have tines at least 2500 mm so that the cable drums are adequately supported by both drum flanges.

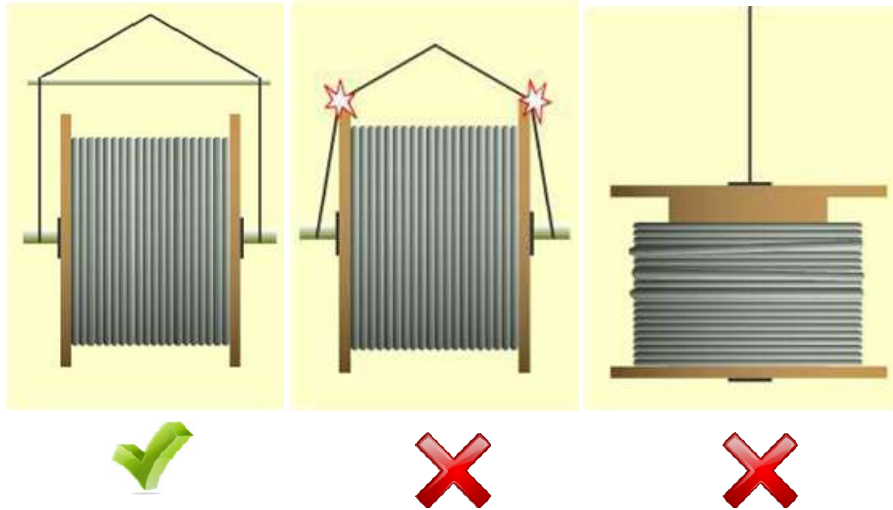
Some drums may be of sufficient length and weight to require cranes to load and unload from transport vehicles. In this case, it will be necessary to ensure that a spreader bar of sufficient length is used to ensure the lifting chains do not compress the drum flanges.

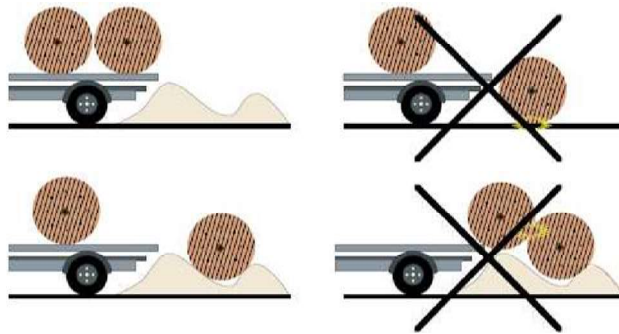
When forklift or crane is not available, a makeshift ramp with approximate inclination of 1:4 should be constructed. The cable drum should then be rolled over this ramp by means of ropes or winches. Additionally, a sand bed at the foot of the ramp can be build to brake the rolling cable drum.

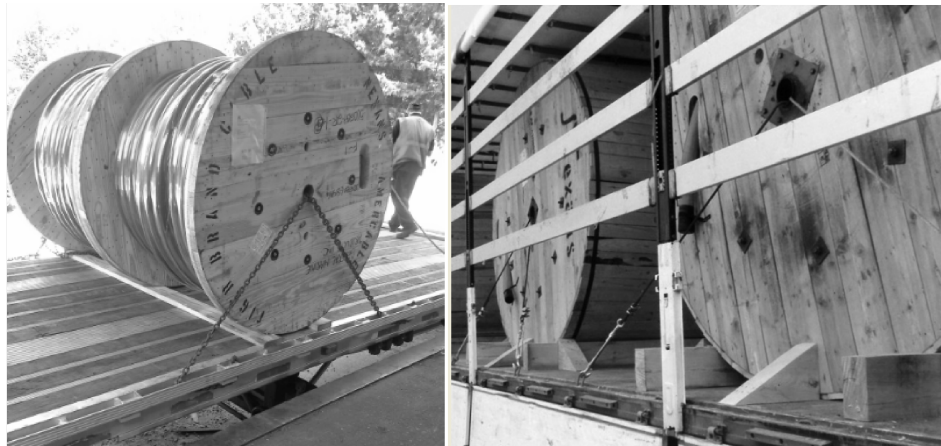
When the drums loaded on trucks are larger than 250cm, binding must be made with ropes crossing through the central hole and if necessary on the drum flanges.

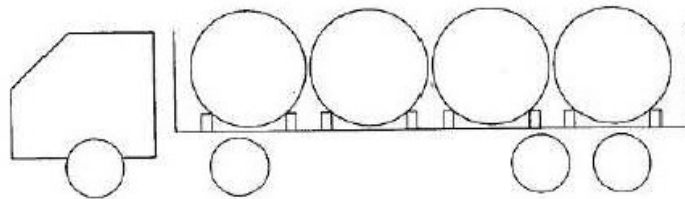
"Bore perpendicular" chocking

The drums are placed parallel to the lorry axis

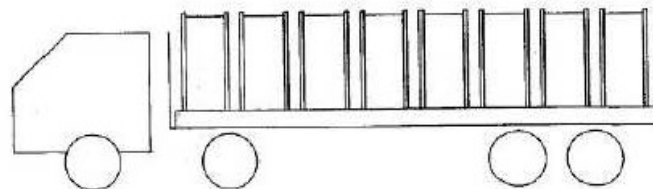
"Bore parallel" chocking

The drums are placed perpendicular to the lorry axis

Provided that the diameter of the drums is less than the width of the lorry, they can be loaded " bore parallel chocking "

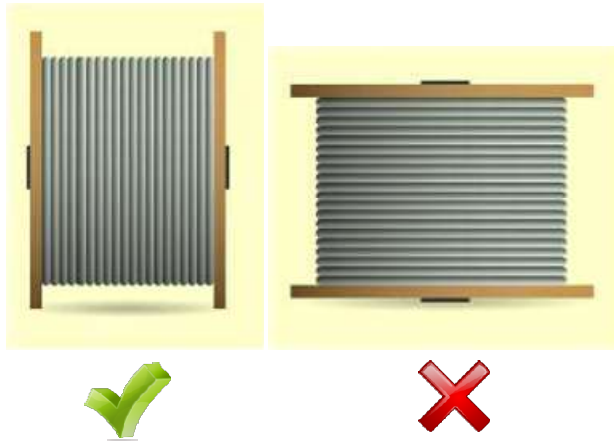
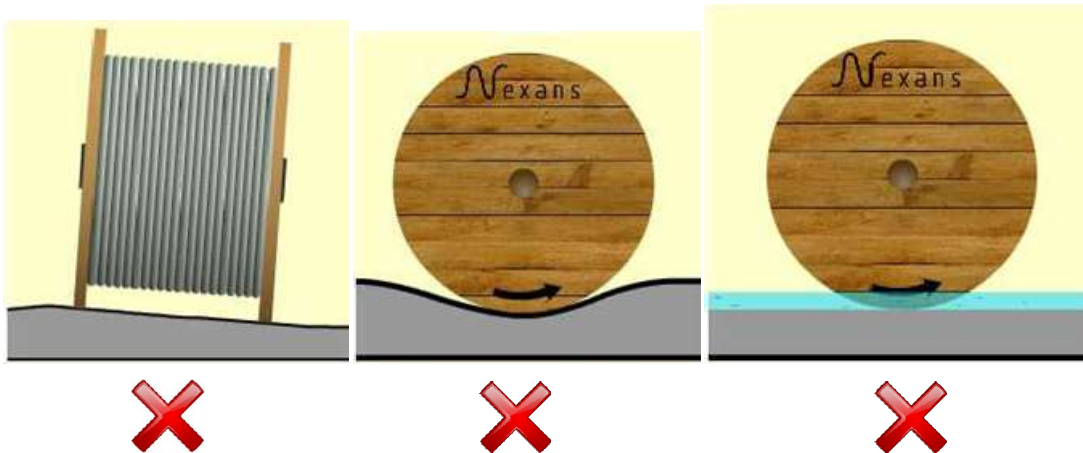
Drums should be stored on a level and firm surface (e.g. timber baulks, firm gravel, or concrete), on the flange edges (not with the flange flat on the ground), such that they will not be standing in water or in continually damp conditions, and restricted from rolling.

Failure to provide these conditions is likely to result in timber rot and weakening of the flange with potential breaks of the flange or collapse of the drum to the point where the cable itself will rest on the ground. Any of these outcomes will make installation of the cable more problematic or impossible.

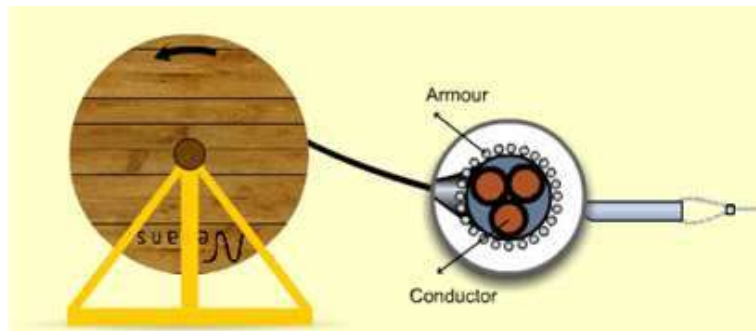
Cable ends will be protected by end caps or by pulling eyes. For longer lengths of cable (perhaps over 800 m) or for large conductor sizes (over 630 mm²), Nexans recommends the use of pulling eyes fixed to the main conductors of the cable. Pulling long and heavy cables by pulling socks can lead to cable or sheath damage.

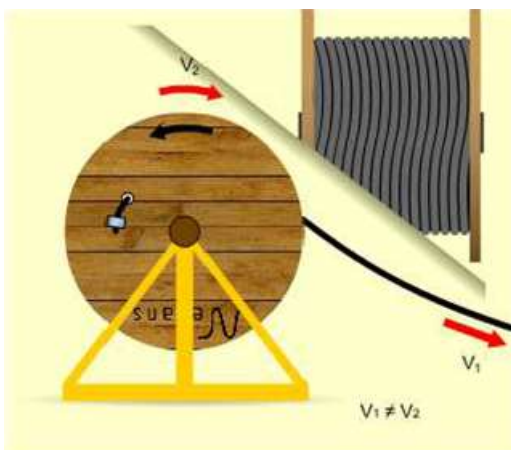
Fixed Cable End – Creepage occurs

To avoid creepage and sinuous shape on the barrel of the drum during paying off, the inner end of the cable on the drum flange should be free, not fixed to the drum.

The inside end of the cable has a tendency to creep through the hole in the flange when the drum is revolved in the opposite direction to that originally employed when winding the cable onto it. This tendency cannot be prevented. The amount of creepage depends on the length of the cable on the drum, the size of the cable and the number of times the drum is revolved. The accumulated slack due to unwinding long lengths of cable may amount to several metres. It can become extensive when the timber drums bolts have loosened or the timber has aged and shrinkage has taken place.

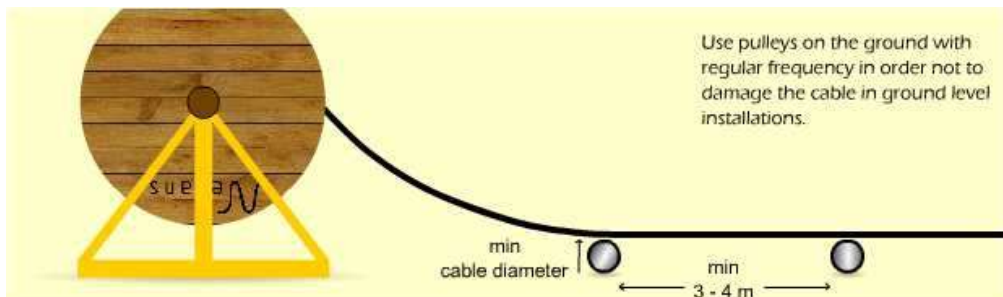
For long circuits, where long lengths or heavy cables are used, pulling tension calculations should be performed for each cable section. Pulling methodology should be prepared clearly detailing the drum position, position of winches or caterpushers, and the number and type of rollers to be employed. For direct buried installations, rollers should be used at 3-4 metre intervals, with more frequent rollers at bends

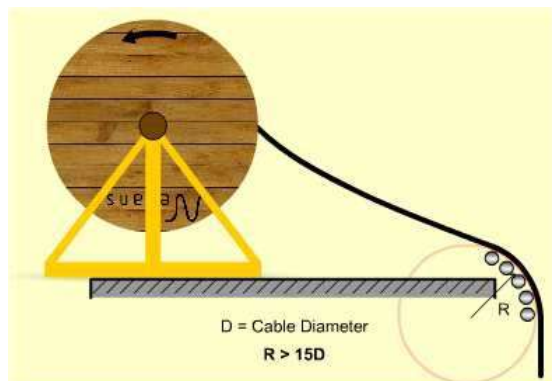
Ducting at cable bends must be selected so the curvature is not below the minimum bending radius during installation. When using rollers at cable changes in direction, it is recommended a number of rollers are used forming a radius that is larger than the minimum bending radius.

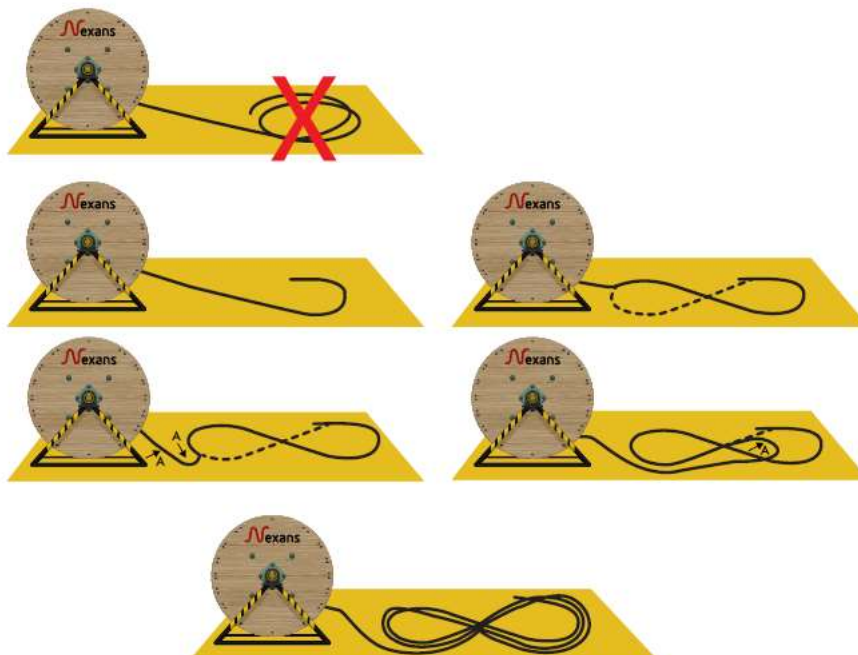
While laying the cables on ground, coiling of the cable on ground should be avoided by applying eight formation to the cable:
